## MONTANA FISH AND GAME DEPARTMENT

## NARRATIVE REPORT

Name: Southeastern Montana Fishery StudyProject No: 29-I-0Title: Summary on the ACP Program for  
Rock CreekPeriod Covered: December 1957 to June 1958

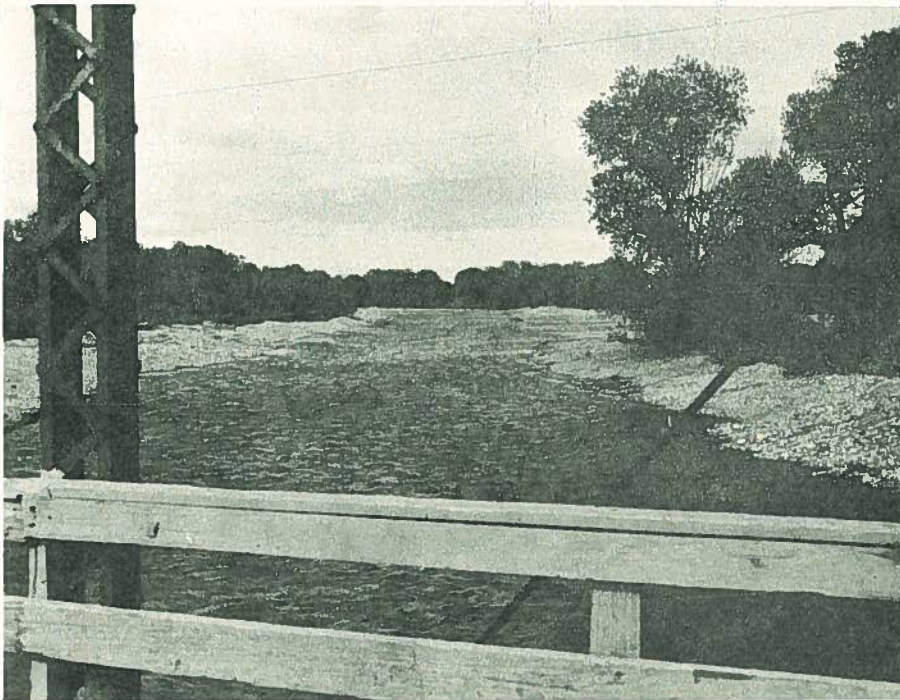
Picture 4. Channel work on Rock Creek at Mont Aqua, another fisherman access point. (Photo - PHN - 5/13/58)

A number of fishermen also signified disapproval of the project, especially since it was a federal cost-sharing project. ( Pictures 3 and 4).

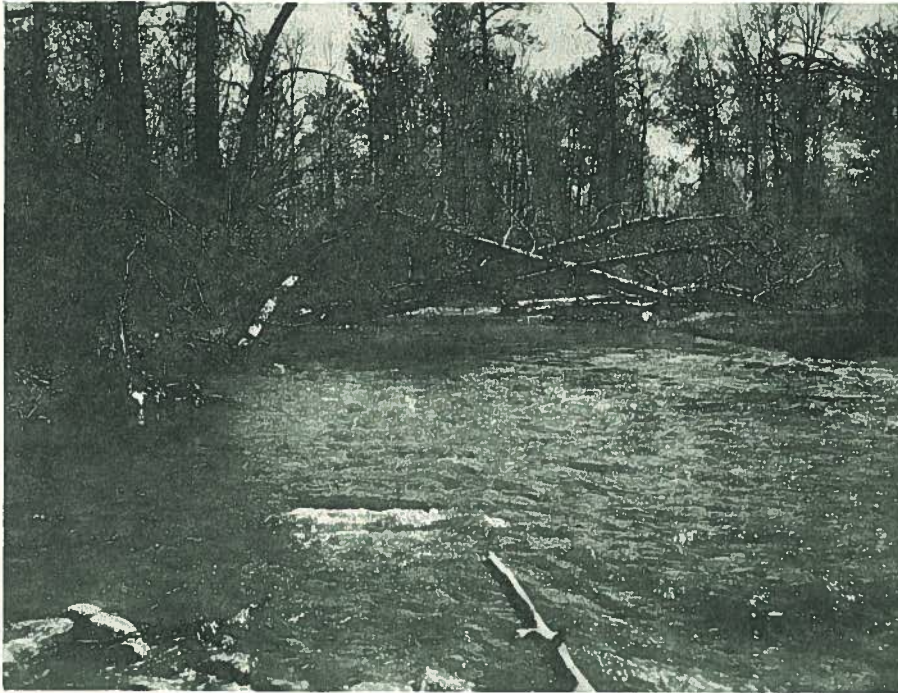
While bank cover is not the entire answer to wise watershed use, it is apparent that bank cover is intact on both banks, the creek typically has a narrow, deeper meandering channel with good trout pools and undercut bank. (Pictures 5 and 6).

Picture 5. Rock Creek illustrating a fairly well-contained creek with minimum of bank erosion. Also good trout habitat occurs in pool under base of tree overhanging the water undercut bank along the left side. The F-3 practice supervisors proposed removal of such trees to prevent erosion. (Photo - PHN - 5-13-58)

4. I believe the SCS and the ACP are interested in good conservation, but little conservation will be accomplished until all the agencies and the individuals in them are aware of what constitutes conservation. From a fishery biologist's standpoint, I can only assume that to date, the value and needs of fisheries has either been ignored or misunderstood on Rock Creek because good trout habitat has been and can be destroyed by work on the F-3 practice. (Picture 5).

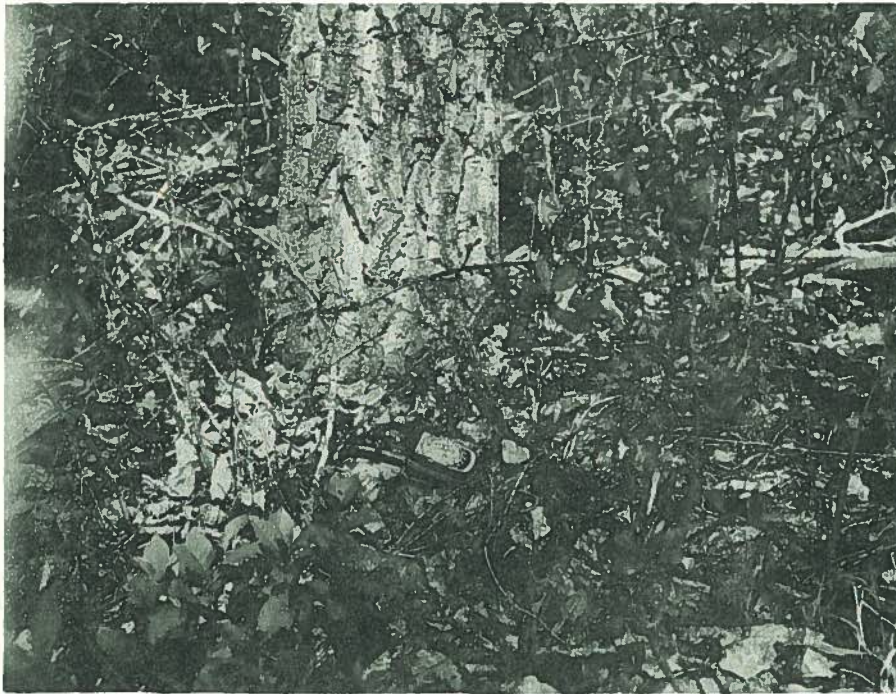
Picture 6. Illustrates vegetation typical of the creek shown in picture 5. Notice amount and age groups of vegetation. Some livestock also use this portion of the flood plain.  
(Photo - PHN - 5-13-58)

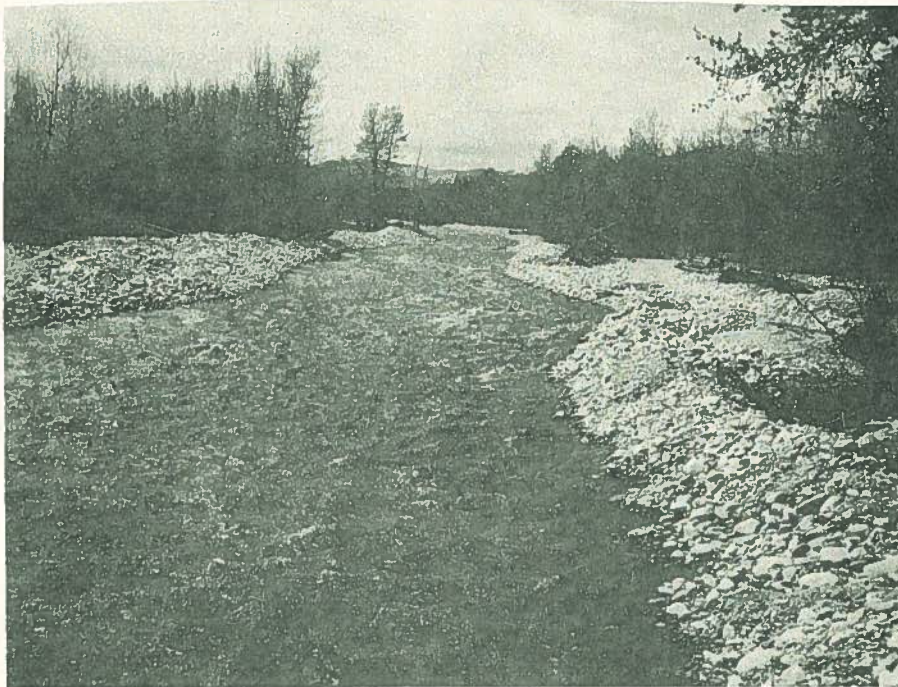
Where bank cover has been abused, the creek has a broad shallow channel with actively cutting banks and little trout habitat. (Pictures 7 and 8).

Picture 7. Rock Creek illustrating poorly vegetated banks, channel work by the F-3 practice and lack of trout habitat.  
(Photo - PHN - 5-14-58)

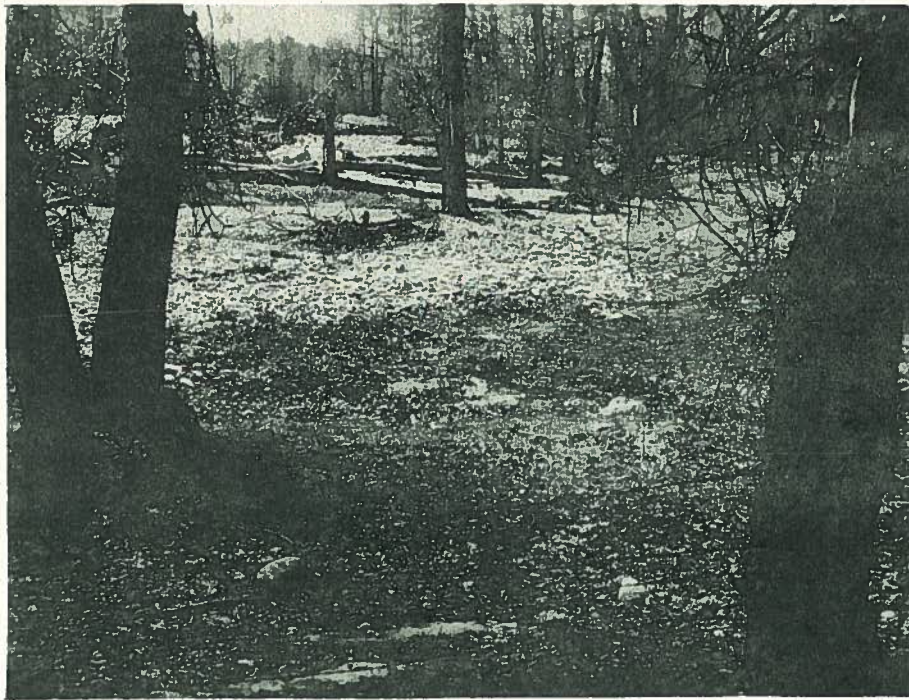
Picture 8. Pasture land along Rock Creek Flood plain in vicinity of picture 7. Note lack of vegetative cover except for mature trees, weeds and grasses. (Photo - PHN - 5-14-58)

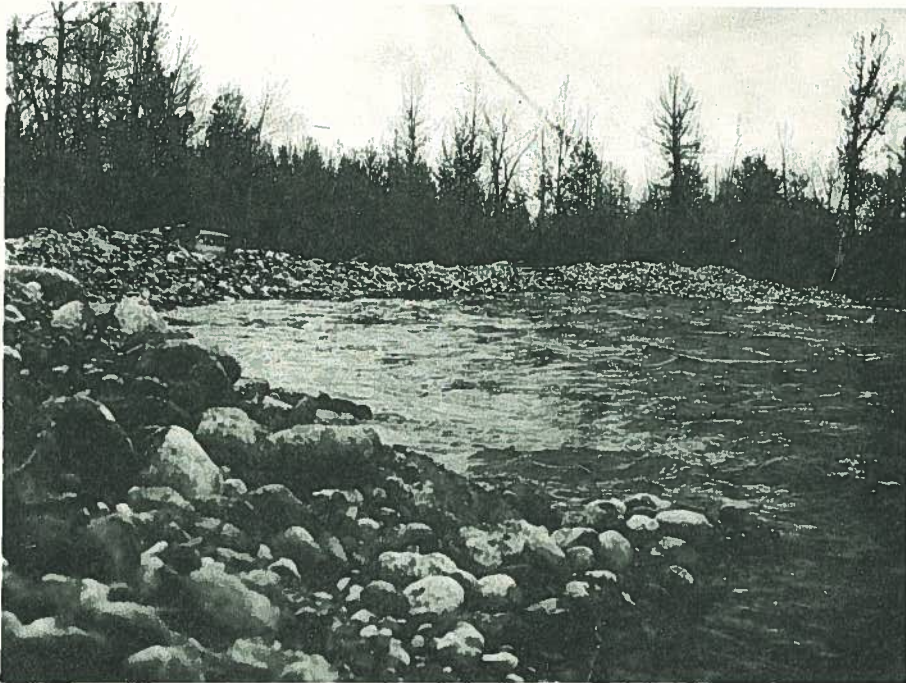
Picture 9. View of Rock Creek electric stream census section 3, after channel work under the F-3 practice. This section of stream on the Joe Allen Ranch was sampled electrically September 11, 1957, prior to F-3 practice. The following fish were taken; 119 brown trout, 16 Rocky Mountain whitefish, 4 eastern brook trout, 10 suckers and 1 chub. All of the larger fish came from a hole that once existed in the foreground because of an overhanging tree, and from an undercut bank to the right of the motor vehicle. This hole and undercut bank was filled with gravel and rubble under a conservation program.

1. Ask that they evaluate their program since we do not feel the F-3 practice solves the basic problem, nor is it hardly a conservation measure.
2. It is felt that the basic problem is more the result of land use in the natural flood plain rather than the 1957 flood. Perhaps the U.S.D.A. could figure out a conservation practice more compatible with fisheries. They have many federal cost-sharing practices. One similar to the Soil Bank might be formulated to pay the rancher to take the flood plain land out of production.
3. Rock Creek is a valuable natural trout fishery. (Picture 9).
